Inspection #: 202409-08035 Inspector: Duncan Lyons

Date: 9/24/2024 Clients Agent: Andrew Quintong

Dwelling Address: 8200 Jantzen Rd #197 Real Estate Company: Green Valley Homes

Modesto, CA 95357

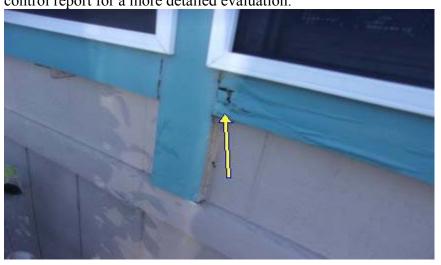
1105. Trim **Review.** Wood. Wood deterioration observed at front, right side. Suggest repairs/replacement as needed. Suggest reviewing latest pest control report for a more detailed evaluation.

1105. Trim **Review.** Wood deterioration observed at front, right side.

Suggest repairs/replacement as needed. Suggest reviewing latest pest control report for a more detailed evaluation.

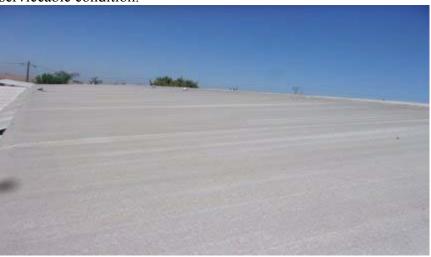
1205. Conditions

Roof shows normal wear for its age and type. No damaged, deteriorated, or missing roofing materials were observed; it appears to be in serviceable condition.

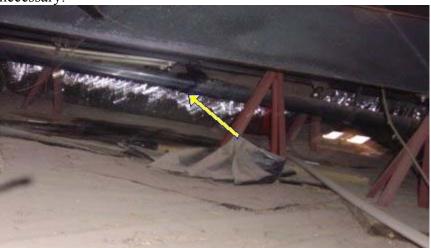
2313. Visible Plumbing

Review. ABS; CPVC. Leaking observed at main sewer line. Recommend review by a licensed plumber for repair or replacement, as necessary.

Review. Leaking observed at main sewer line. Recommend review by a licensed plumber for repair or replacement, as
