WOOD DESTROYING PESTS AND ORGANISMS INSPECTION REPORT

Building No. 275-105	Street Burnett Avenue	City Morgan Hill	ZIP 95037	Date of Inspection 10/24/2024	Number of Pages 7
-------------------------	--------------------------	---------------------	--------------	----------------------------------	----------------------

Report # : 15563
 Registration # : PR6613
 Escrow # :
 CORRECTED REPORT

GENERAL DESCRIPTION: One story mobile home, furnished.	Inspection Tag Posted: WATER HEATER CLOSET Other Tags Posted:
---	---

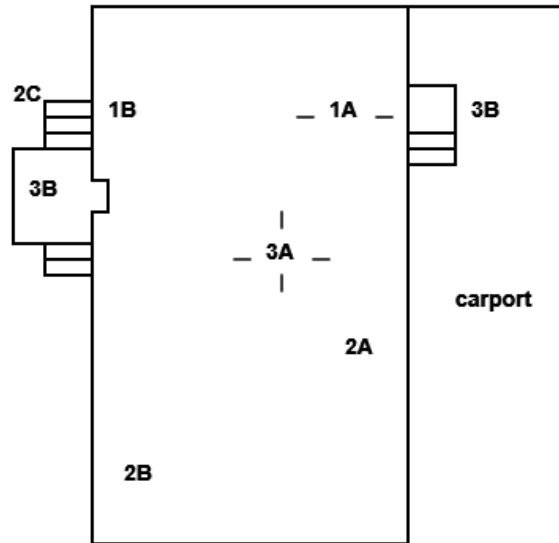
Diagram Not To Scale

FINDING: Fungus damage, noted as 1B on the diagram, was found to the siding.

FINDING: Water stains at the front bedroom ceiling noted as 2B on the diagram. It was not possible to determine if stains were from past or present leakage.

FINDING: Exterior wood members are noted as weathered, 2C on the diagram.

FINDING: No access to subarea under stairway and/or deck, 3B on the diagram.

RECOMMENDATION: Remove and replace the damaged wood members. This company does not paint.

RECOMMENDATION: This Company does not certify roofs. We recommend owner to contact licensed contractor if further inspection of roof is desired.

RECOMMENDATION: Owner to maintain all exterior wood members in a water tight fashion (paint, caulk, etc.).

RECOMMENDATION: Install an access vent to the area beneath the stairway to allow for an inspection. After access vent is installed, this company will inspect the area and issue a supplemental report. An additional charge will be made for this inspection.
