Duncan Inspection Services

Inspection #:	202601-08182	Inspector:	Duncan Lyons
Date:	1/13/2026	Clients Agent:	Andrew Quintong
Dwelling Address:	8200 Jantzen Rd #156 Modesto, CA 95357	Real Estate Company:	Green Valley Homes
Client Name:	Elida Refana

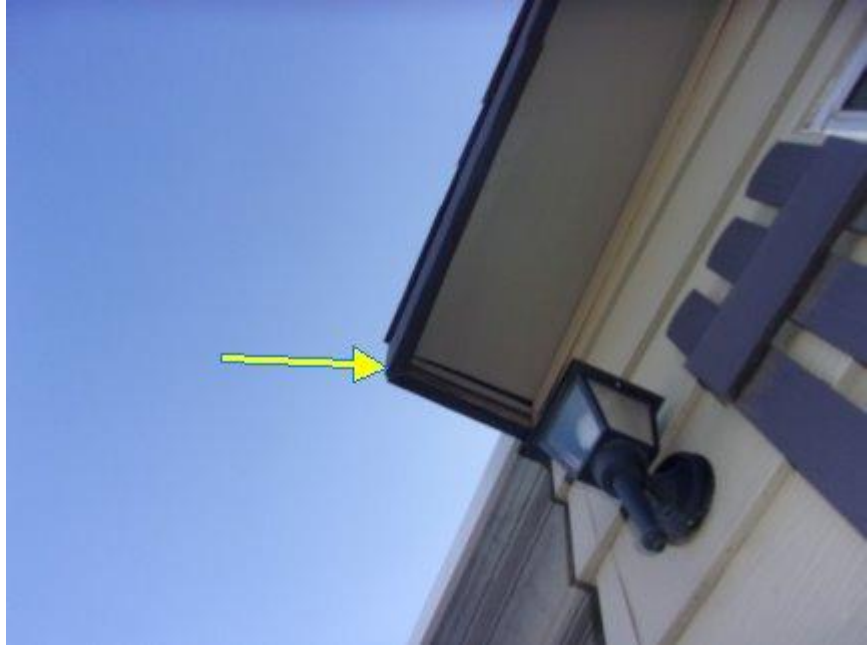
1104. Eaves / Soffits / Fascias **Review.** Wood. Wood deterioration observed at front. Suggest repairs/replacement as needed. Suggest reviewing latest pest control report for a more detailed evaluation.

1104. Eaves / Soffits / Fascias **Review.** Wood deterioration observed at front. Suggest repairs/replacement as needed. Suggest reviewing latest pest control report for a more detailed evaluation.

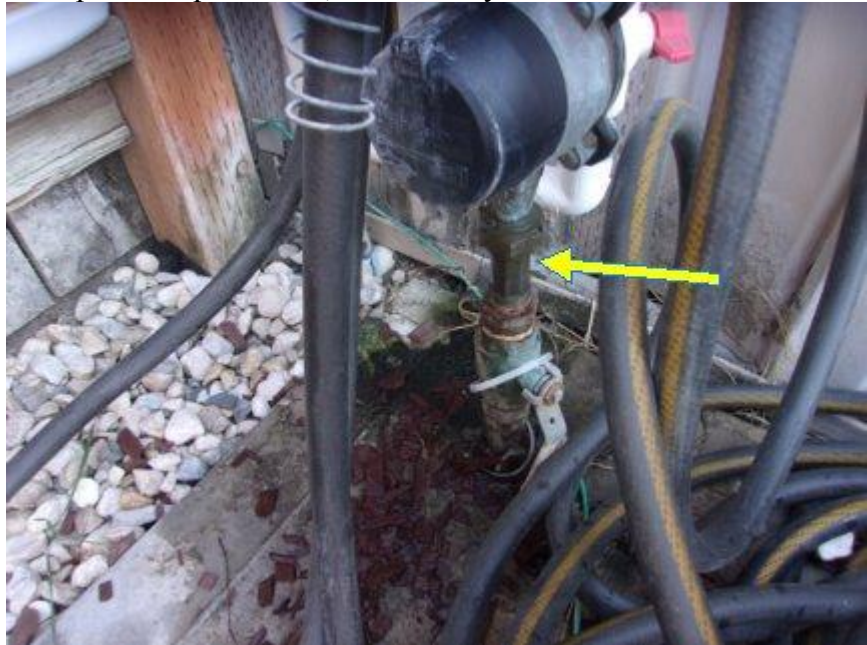
Step #	Component	Comment
1501.	Water Supply System	Water supply appears to be connected to the public system.
1502.	Shut Off Valve Location	Review. Leak. Main shut-off is located at the right side. Leak observed at the main shut-off valve. Recommend review by a licensed plumber for repair or replacement, as necessary.

Since main shut-off valves are operated infrequently, it is not unusual for them to become frozen over time. They often leak or break when operated after a period of inactivity. For this reason main shut-off valves are not tested during a home inspection. We suggest caution when operating shut-offs that have not been turned for a long period of time. All shut-off valves and angle stops should be turned regularly to ensure free movement in case of emergency.

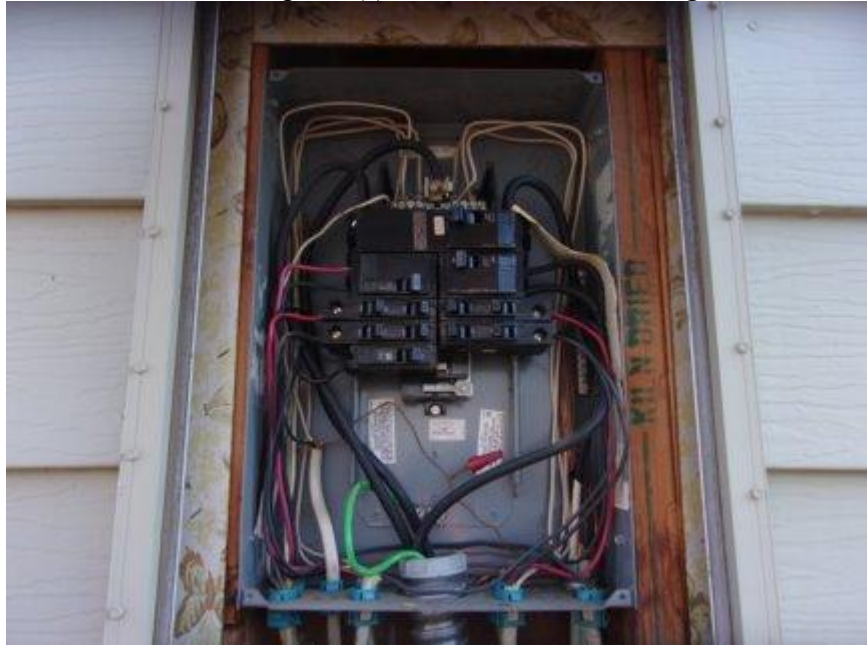
1606. Sub-Panel Comments Serviceable. The sub-panel(s) is located in exterior right.

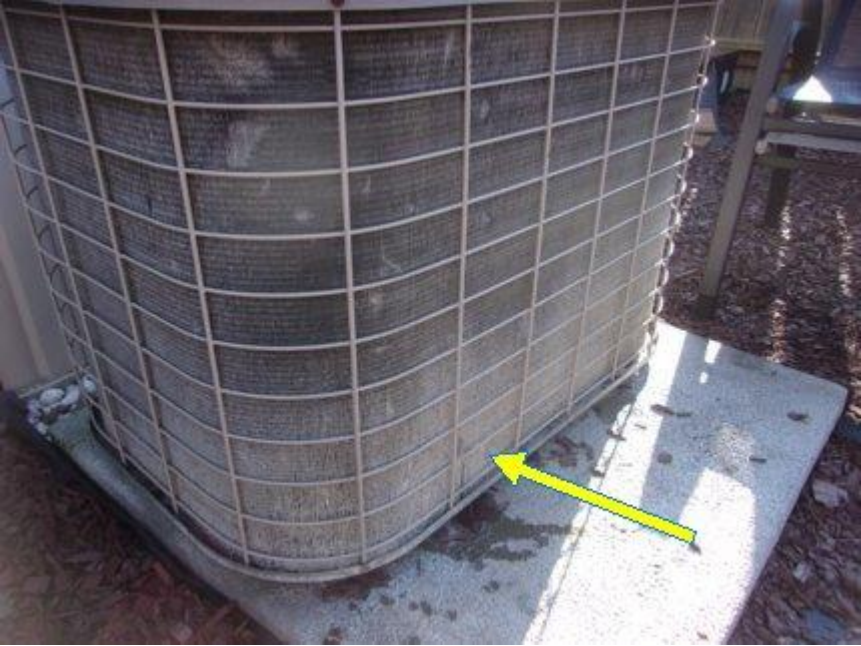
Step #	Component	Comment
1801.	Location of unit	The Air conditioning system is located at the right side
1802.	Air Conditioning Design Type/Brand	Split system.
1803.	General Conditions	<p>Review. The fins on the condenser unit have been deformed over a significant area. With this condition, efficiency and life expectancy go down and operation costs go up. We suggest consulting a qualified HVAC company for further evaluation and any necessary repairs.</p>

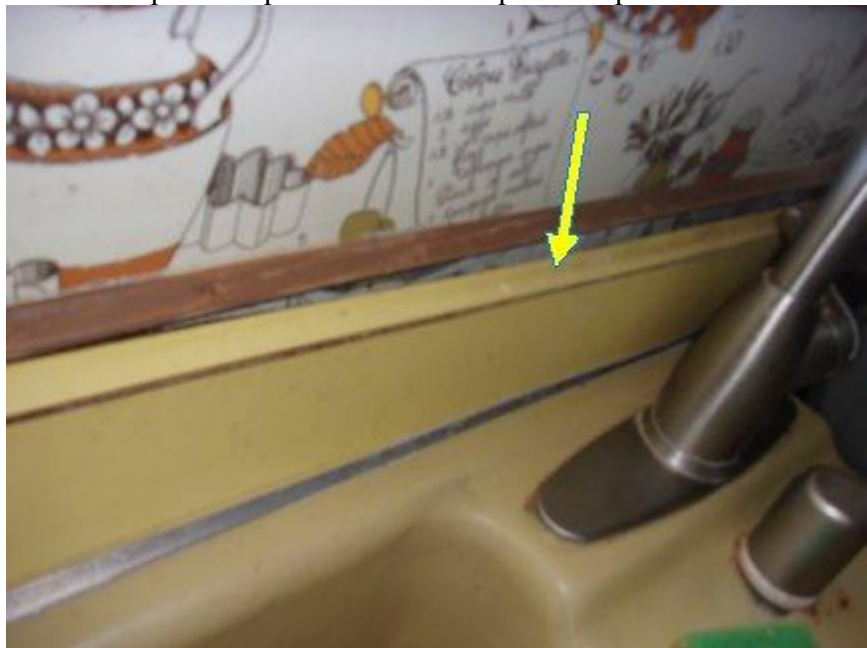
Step #	Component	Comment
3101.	Floor	Linoleum.
3102.	Walls	Serviceable. Paneled; Wallpaper.
3103.	Ceiling	Serviceable. Paneling.
3104.	Ceiling fan	Not Present.
3105.	Doors	Not Present.
3106.	Windows	Serviceable. Aluminum frame.
3107.	Heat / Cooling Source	Serviceable. Central heating/cooling.
3108.	Electrical	Review. Light fixtures at kitchen were inoperative at time of inspection. Suggest client verify fixture for proper operation prior to closing. Ground Fault Circuit Interrupters (GFCI) may not have been required when the home was built. Suggest client consider upgrading with GFCI's at all receptacles near water sources, such as the kitchen, the bathrooms, the garage, and exterior receptacles to enhance safety. Upgrades should be performed by a licensed electrician.
3109.	Cabinets	Serviceable.
3110.	Counter Tops	Review. Laminated. Moisture damage observed. Recommend review by a licensed/qualified professional for repair or replacement as necessary.

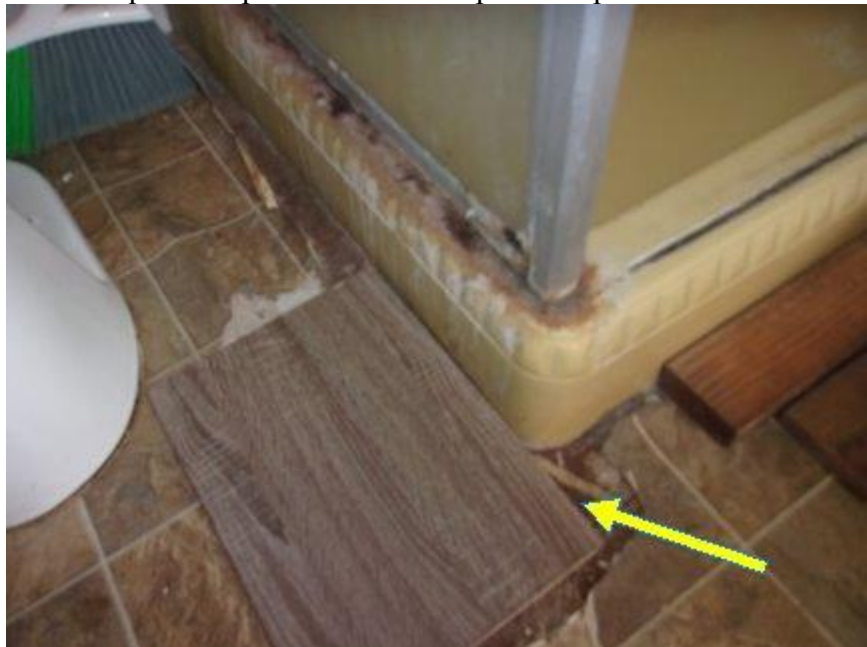
3202.	Floor	Review. Linoleum. Damaged floor observed in the bathroom, recommend corrections as needed. Recommend review by a licensed/qualified professional for repair or replacement as necessary.
-------	-------	---

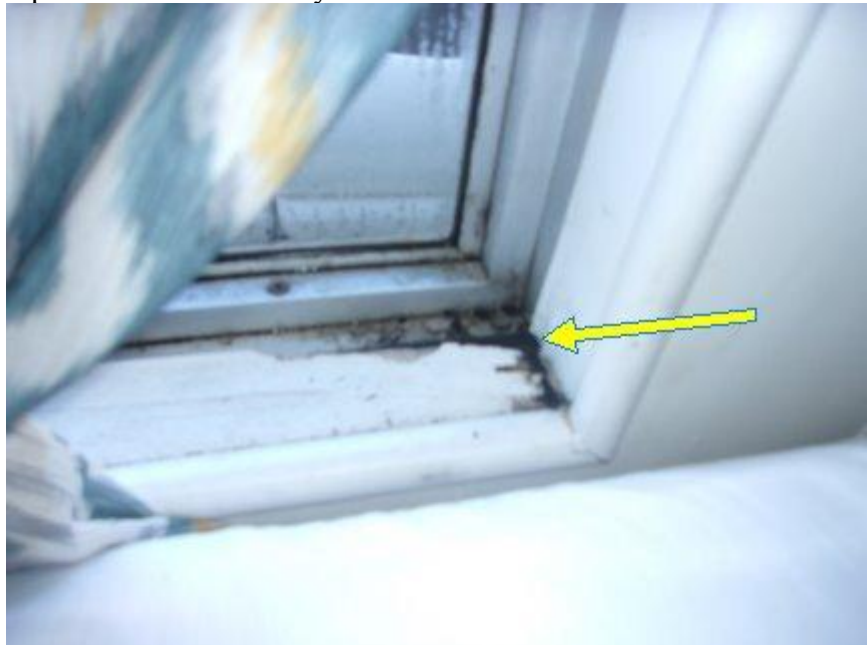
Step #	Component	Comment
3541.	Floors	Carpet.
3542.	Walls	Serviceable. Paneled.
3543.	Ceilings	Serviceable. Paneling.
3544.	Ceiling fan	Not Present.
3545.	Doors	Not Present.
3546.	Closet / Wardrobe	Not Present.
3547.	Windows	Review. Aluminum frame. Water damage/Staining observed at/near window. Possible leaking. Recommend further review for repair or replacement as necessary.

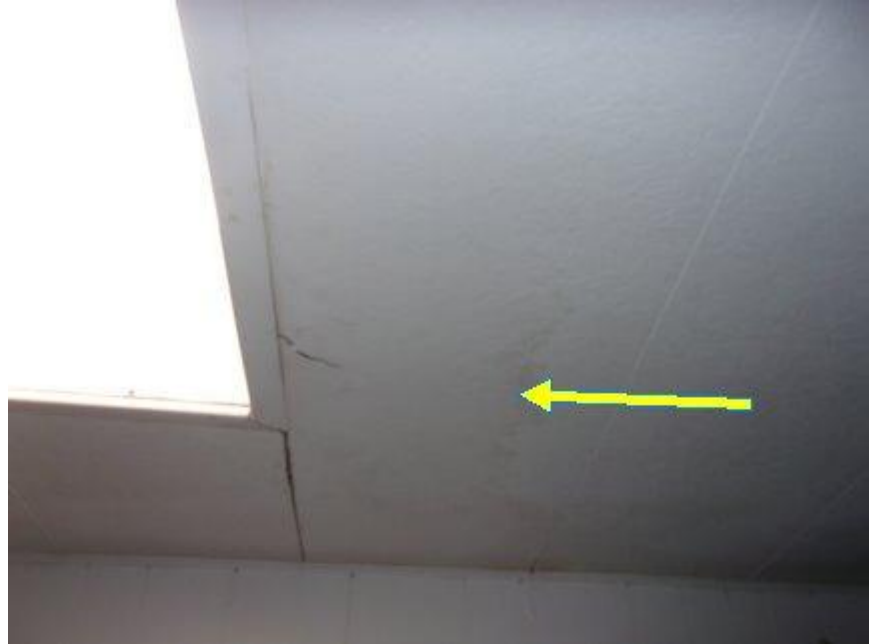
Step #	Component	Comment
3561.	Floors	Serviceable. Carpet.
3562.	Walls	Serviceable. Paneled.
3563.	Ceilings	Review. Paneling. Water stains observed near the skylight. Recommend review by a licensed/qualified professional for repair or replacement as necessary.

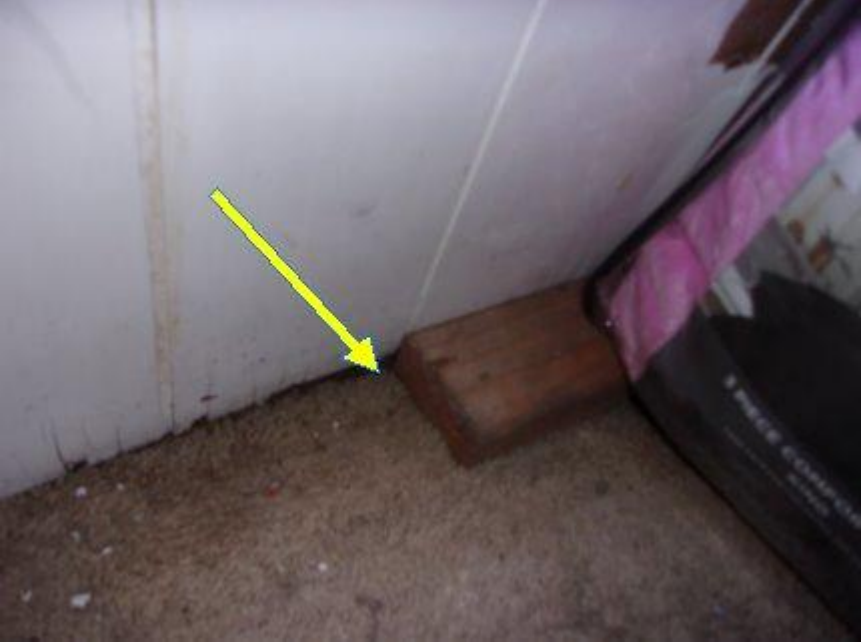
Step #	Component	Comment
3581.	Location	Left rear; Master Bedroom.
3582.	Floors	Review. Carpet. Damaged floor structure observed in the bedroom, recommend corrections as needed. Recommend review by a licensed/qualified professional for repair or replacement as necessary.
