Health and Safety (Title 25) Inspection Report

April 10, 2026

Health and Safety Inspection Report

Inspection Address:275 Burnett Av. #40
Morgan Hill, Ca. 95037**Represented By:**Michelle Quintong
Green Valley Homes
Phone: 408-230-4499
E-mail: michelle@gvhubayarea.com
Lic.: SP1262671

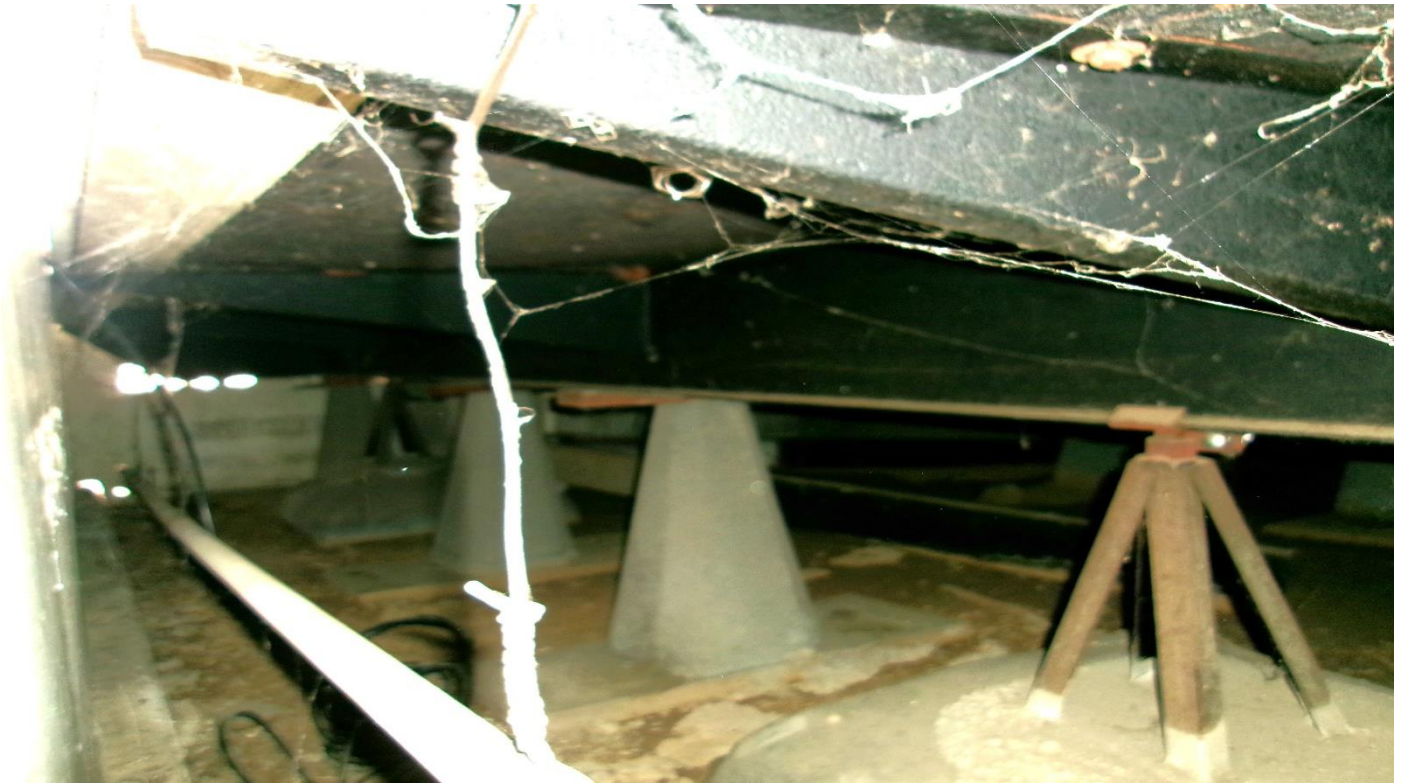
4.2 Foundation bolting / anchoring was installed under the home. Anchoring of the foundation to the home helps to provide stability and minimize shifting of the home during seismic activity. (See Photo)

View of foundation support at the sub-area.

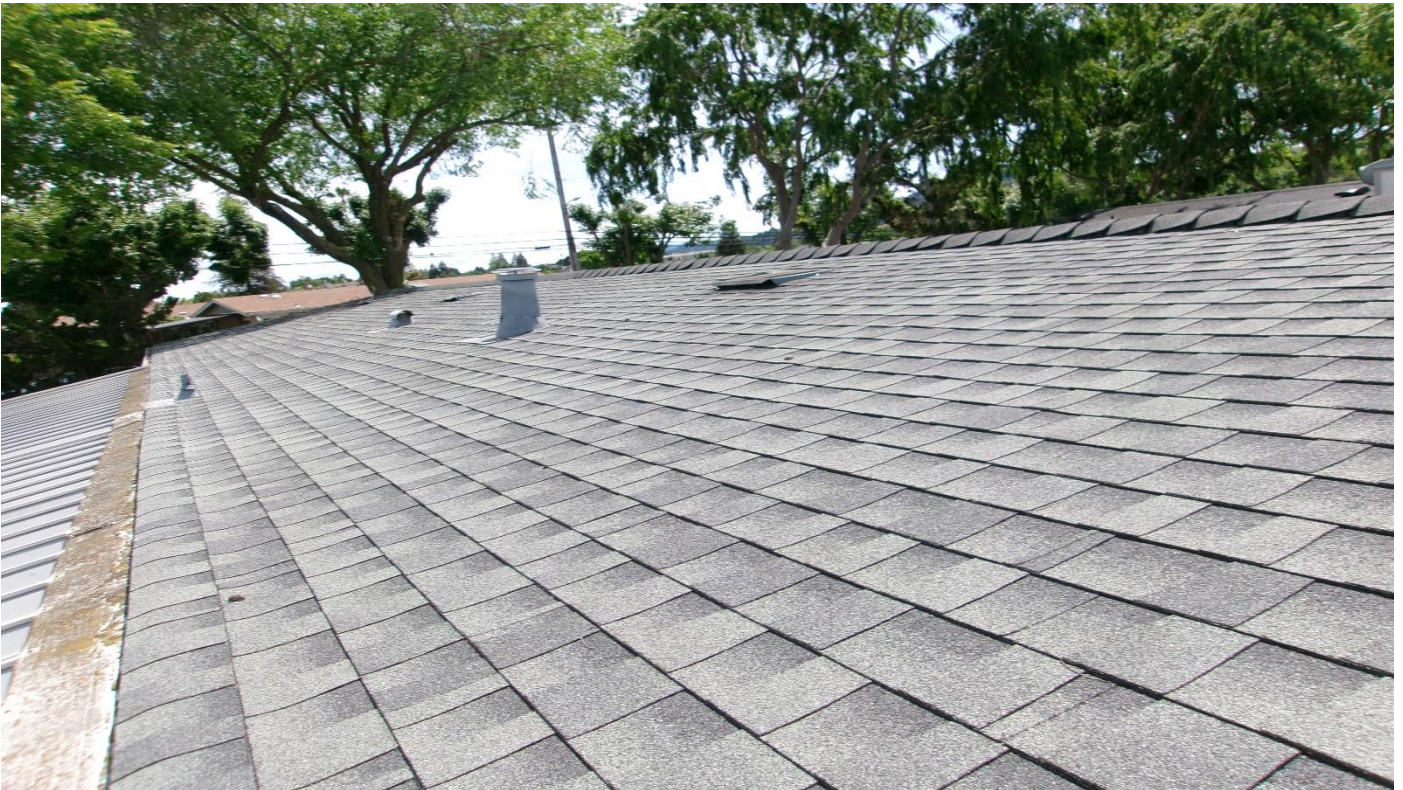
5.1 The roof surface shingles were observed t (see photos). This report is primarily a health and safety inspection. For a detailed assessment of the roof's condition it's recommended that a licensed roof inspector inspect the roof further.

View of the roof surface.

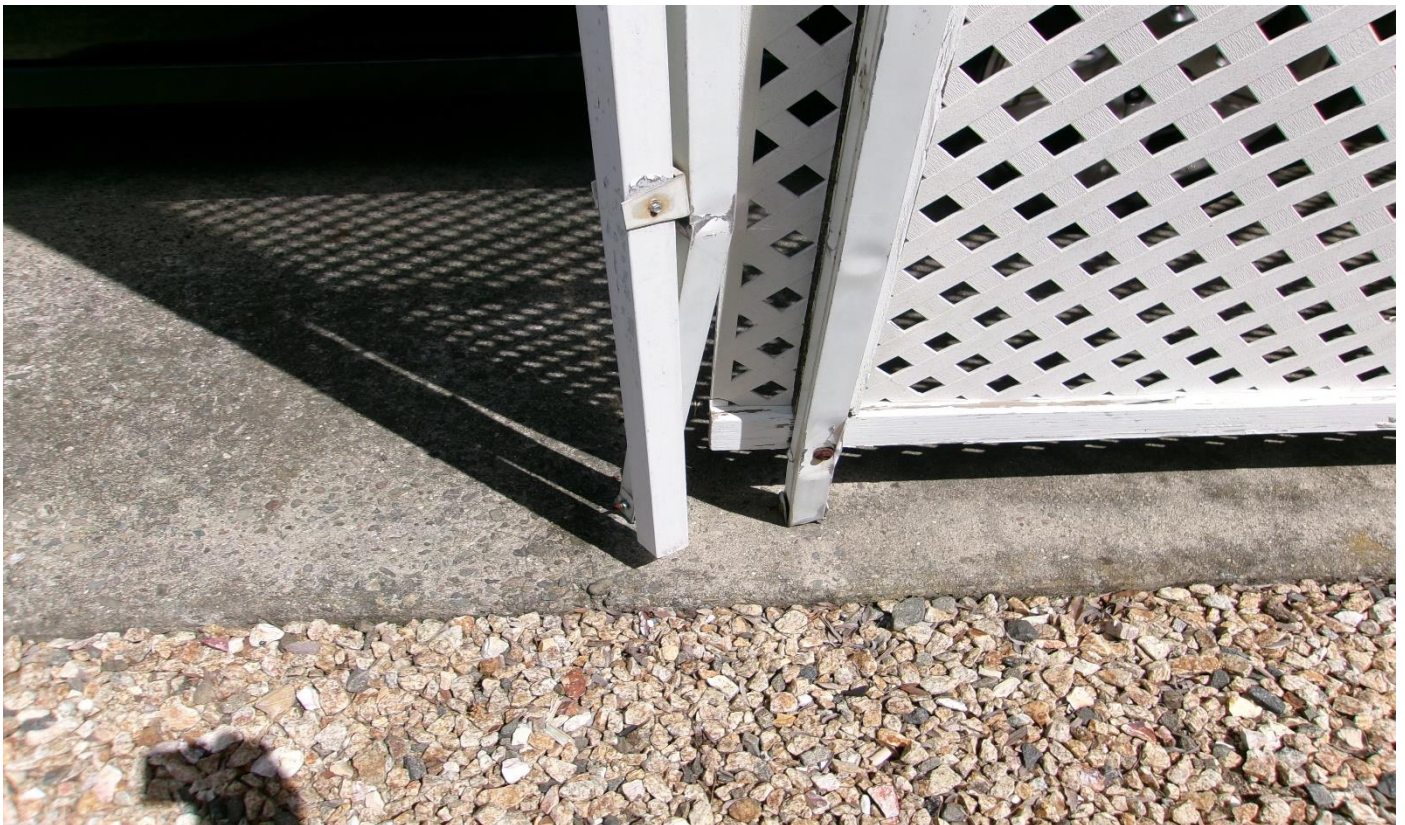
- 8.1 The carport concrete driveway was observed to have a raised / uneven slab at the left rear side of the driveway (see photo). This condition is a tripping hazard. It's recommended that a licensed concrete repair service inspect the raised concrete further and repair as needed. (General Maintenance)
- 8.2 The #1 and #2 carport support posts were both observed to have been damaged (see photos). The damage appears to have been caused by vehicle contact. It's recommended that a handyman replace the two damaged posts with two new matching posts. (General Maintenance)

Damaged #1 carport support post.

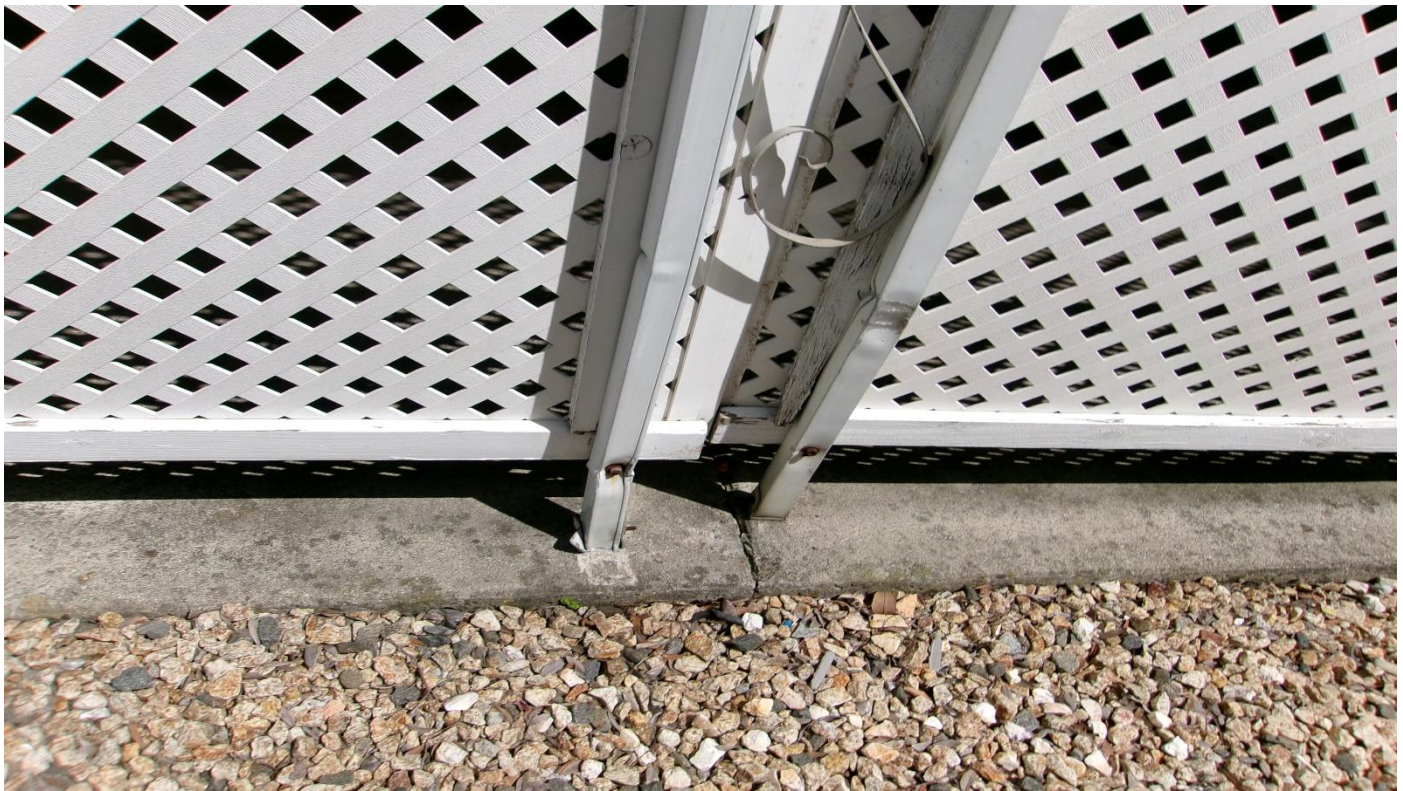
Damaged #2 carport support post.

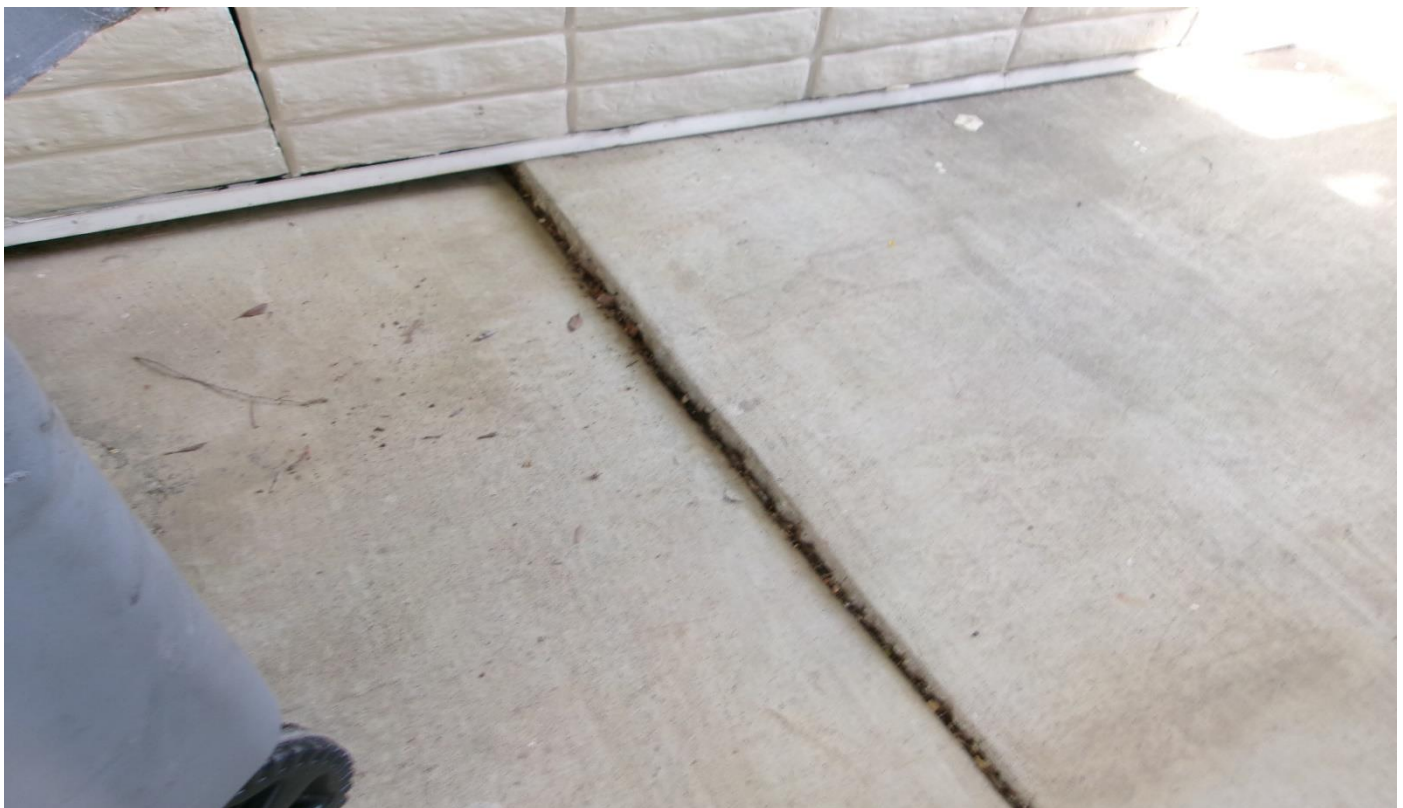
Raised concrete at the rear of the carport.

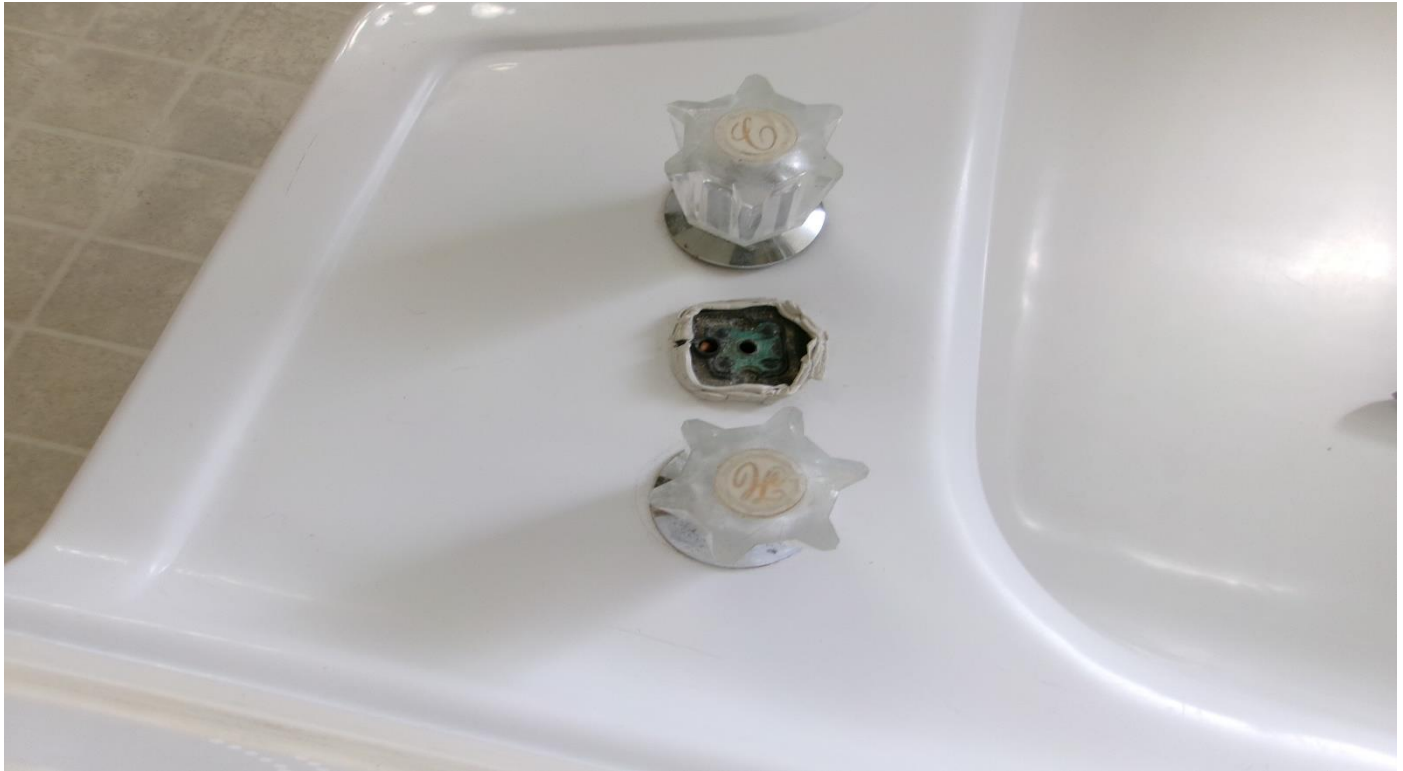
9.3 MASTER BATH: The master bathroom tub faucet was observed to have been removed from the tub. It's recommended that a faucet be properly re-installed at the master bathroom tub. (General Maintenance)

Master bathroom tub faucet has been removed.

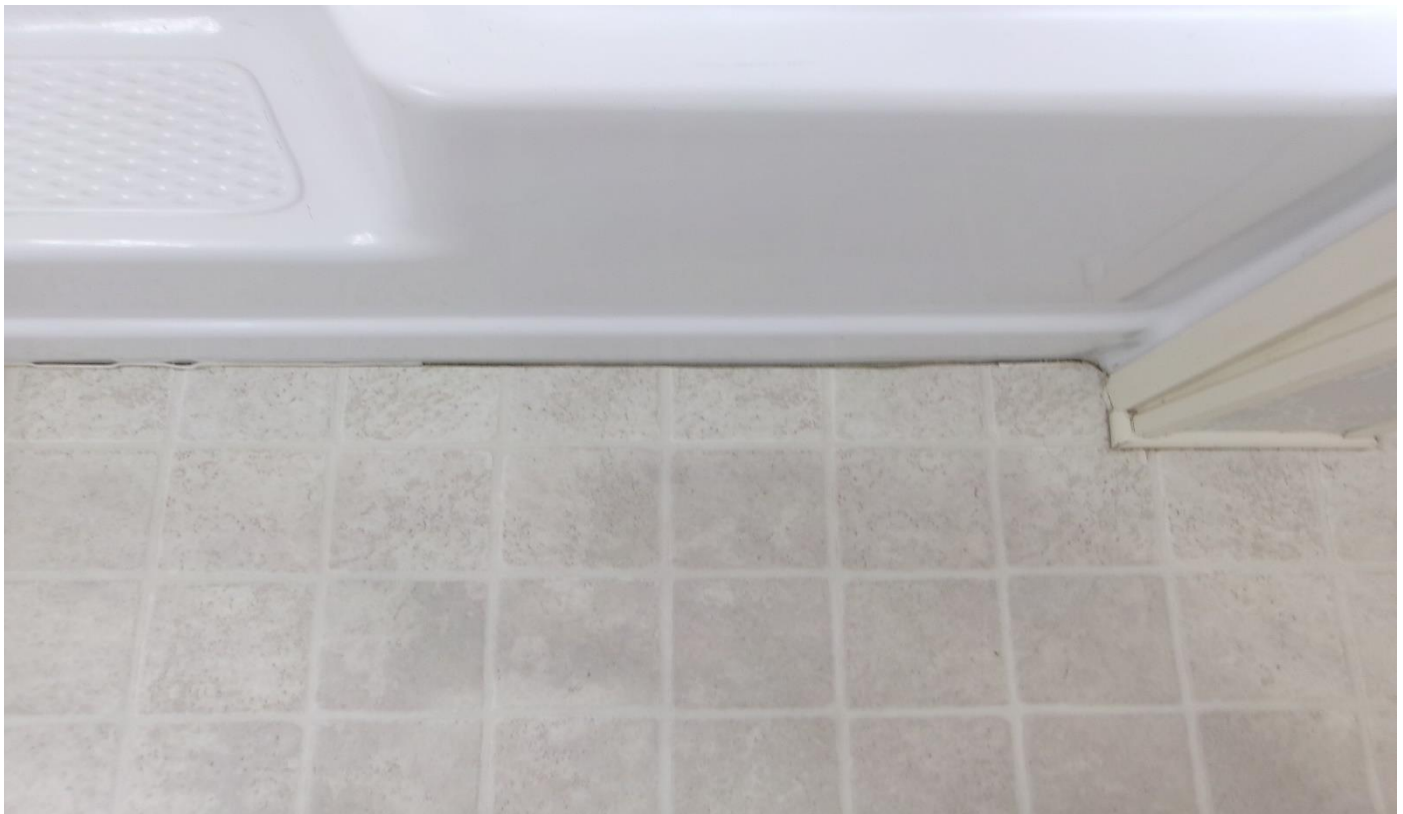
9.4 MASTER BATH: The vinyl sheet flooring installed at the master bathroom was observed to be curling back with an open gap adjacent to the tub (see photo). This condition can cause moisture damage to occur to the sub-flooring at this location. It's recommended that the flooring be properly re-adhered and sealed to the sub-floor framing at this location. (Section 1)

Loose / open vinyl sheet flooring at the master bathroom.
