## Duncan Inspection Services

Inspection #:	202604-08210	Inspector:	Duncan Lyons
Date:	4/17/2026	Clients Agent:	Andrew Quintong
Dwelling Address:	8200 Jantzen Rd #127 Manteca, CA 95337	Real Estate Company:	Green Valley Homes
Client Name:	Connie Soriano

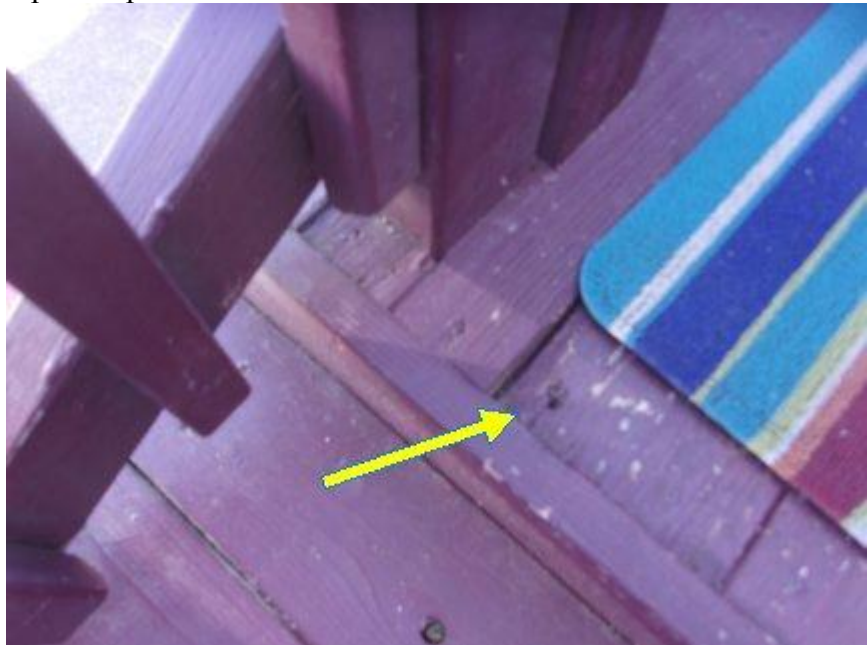
1118.	Retaining Wall(s)	Not Present.
1119.	Patio	Concrete. Common cracks observed.
1120.	Deck	Not Present.
1121.	Balcony	Not Present.
1122.	Porch	<p><b>Review.</b> Wood. Wood deterioration observed at the front porch. Suggest repairs/replacement as needed.</p>

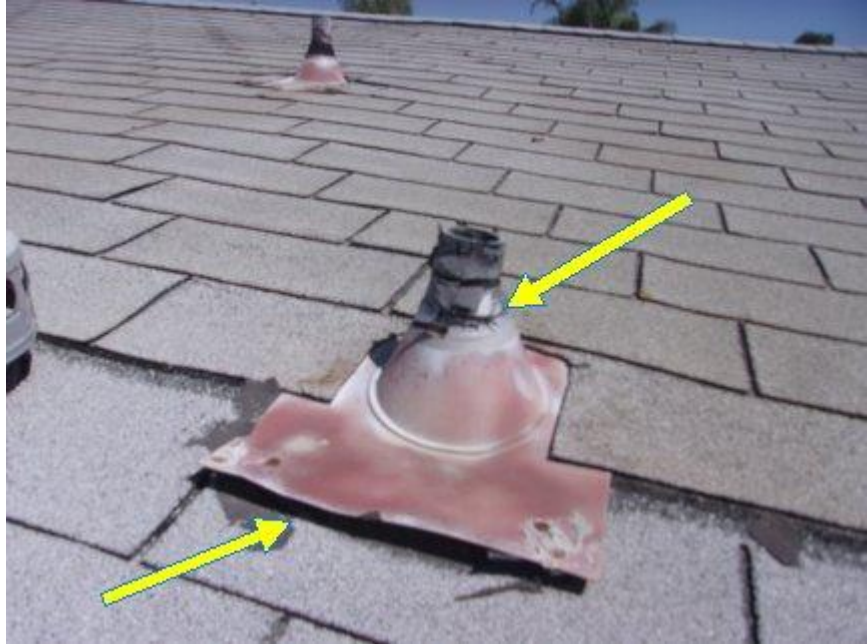
1203. Exposed  
Flashings

**Review.** Recommend re-sealing all flashings and through the roof vents now and as a part of routine maintenance.

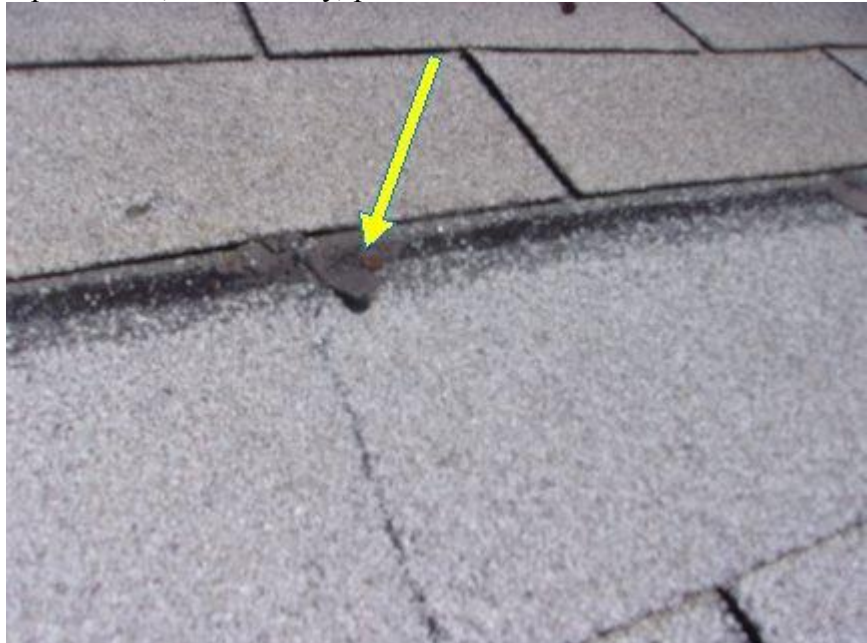
**Review.** Exposed nails observed. Nail heads should be sealed to prevent water penetration. Recommend review by a licensed roofer for repair or replacement, as necessary, prior to close.

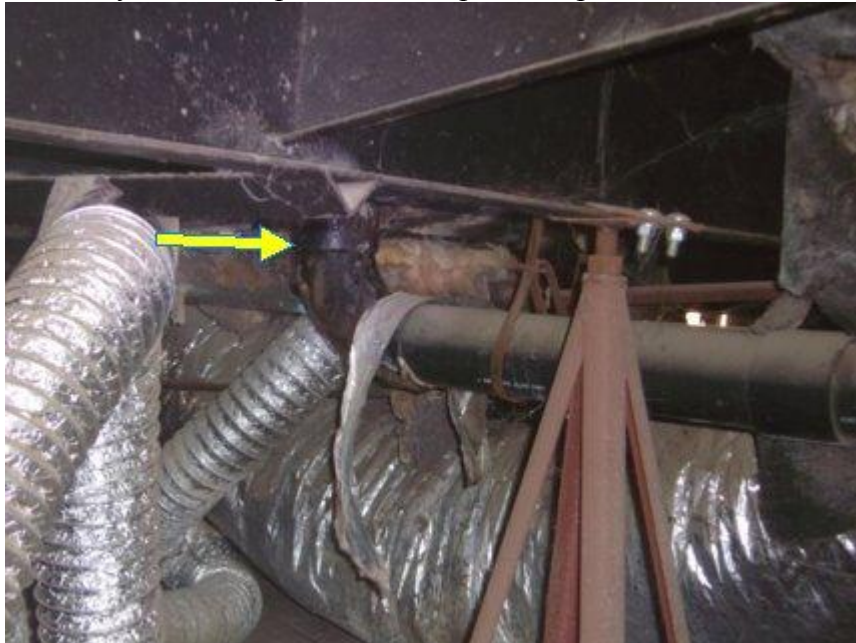
2313. Visible  
Plumbing

**Review.** ABS; Copper. Leaking observed at bathroom. Recommend review by a licensed plumber for repair or replacement, as necessary.

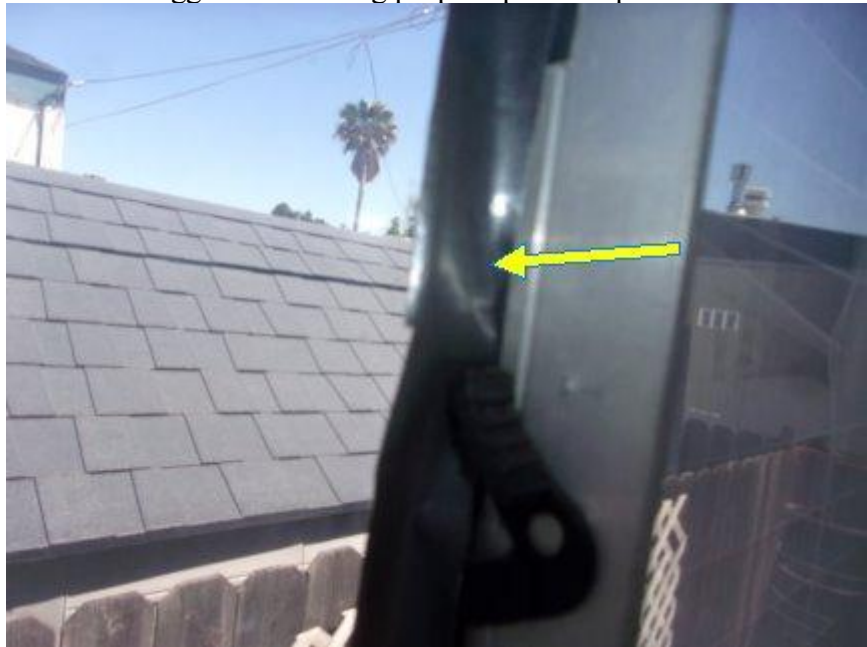
Step #	Component	Comment
3581.	Location	Left rear; Master Bedroom.
3582.	Floors	Serviceable. Carpet.
3583.	Walls	Serviceable. Paneled.
3584.	Ceilings	Serviceable. Paneling.
3585.	Ceiling fan	Not Present.
3586.	Doors	Serviceable. Hollow core.
3587.	Closet / Wardrobe	Serviceable. Sliding Mirror.
3588.	Windows	<b>Review.</b> Aluminum frame. Tapped-shut window(s) observed in the bedroom. Suggest confirming proper operation prior to close.

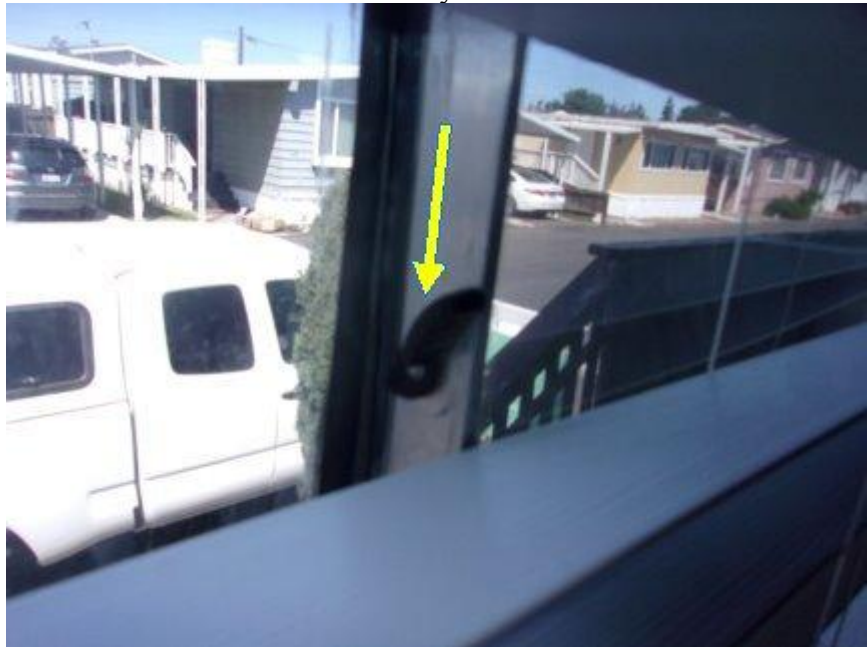
Step #	Component	Comment
3581.2.	Location	Right front.
3582.2.	Floors	Serviceable. Carpet.
3583.2.	Walls	Serviceable. Paneled.
3584.2.	Ceilings	Serviceable. Paneling.
3585.2.	Ceiling fan	Not Present.
3586.2.	Doors	Serviceable. Hollow core.
3587.2.	Closet / Wardrobe	Serviceable. Hollow core sliding.
3588.2.	Windows	<b>Review.</b> Aluminum frame. Window lock(s) is damaged a bedroom. Corrections are needed for security.
