## Duncan Inspection Services

Inspection #:	202605-08217	Inspector:	Duncan Lyons
Date:	5/6/2026	Clients Agent:	Andrew Quintong
Dwelling Address:	8200 Jantzen Rd #107 Modesto, CA 95357	Real Estate Company:	Green Valley Homes
Client Name:	Andre Morton

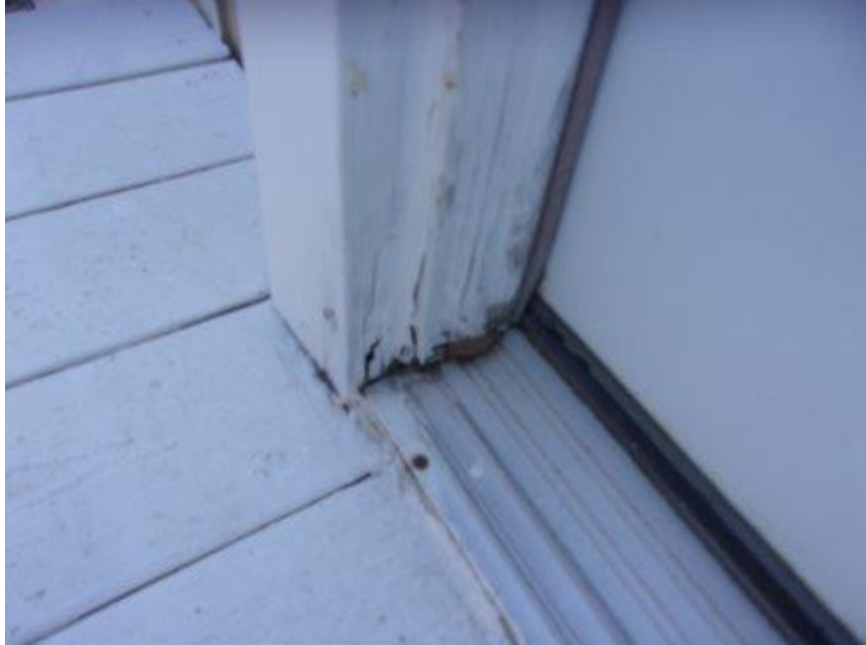
1105. Trim **Review.** Wood. Wood deterioration observed at left side. Suggest repairs/replacement as needed. Suggest reviewing latest pest control report for a more detailed evaluation.

**Review.** Wood deterioration observed at left side. Suggest repairs/replacement as needed. Suggest reviewing latest pest control report for a more detailed evaluation.

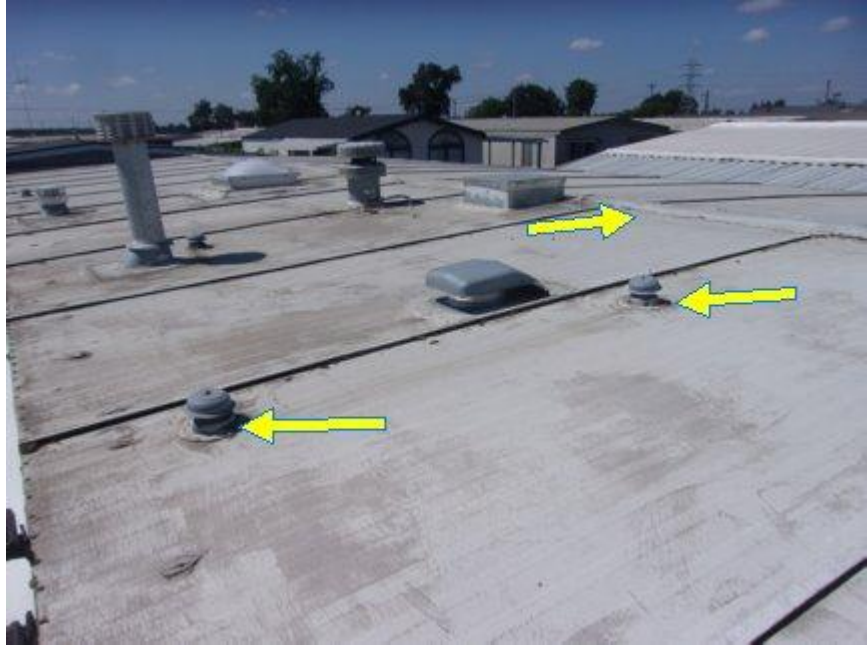
1203. Exposed  
Flashings

**Review.** Metal. Recommend re-sealing all flashings and through the roof vents now and as a part of routine maintenance.

**Review.** Recommend re-sealing all flashings and through the roof vents now and as a part of routine maintenance.

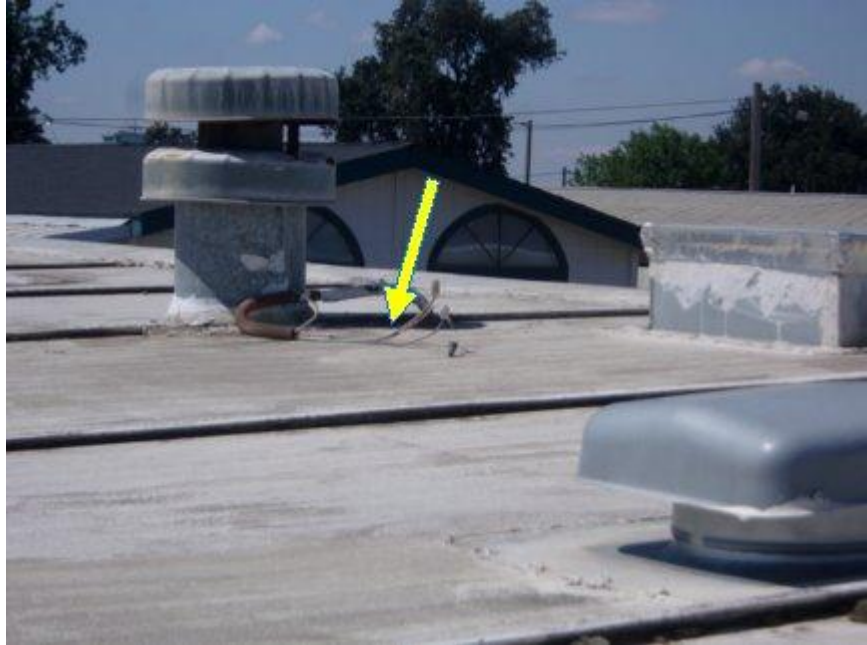
1207a. Roof  
Comments #2

**Review.** Abandoned wires observed at roof these should be corrected/removed for safety by a licensed electrician prior to close.

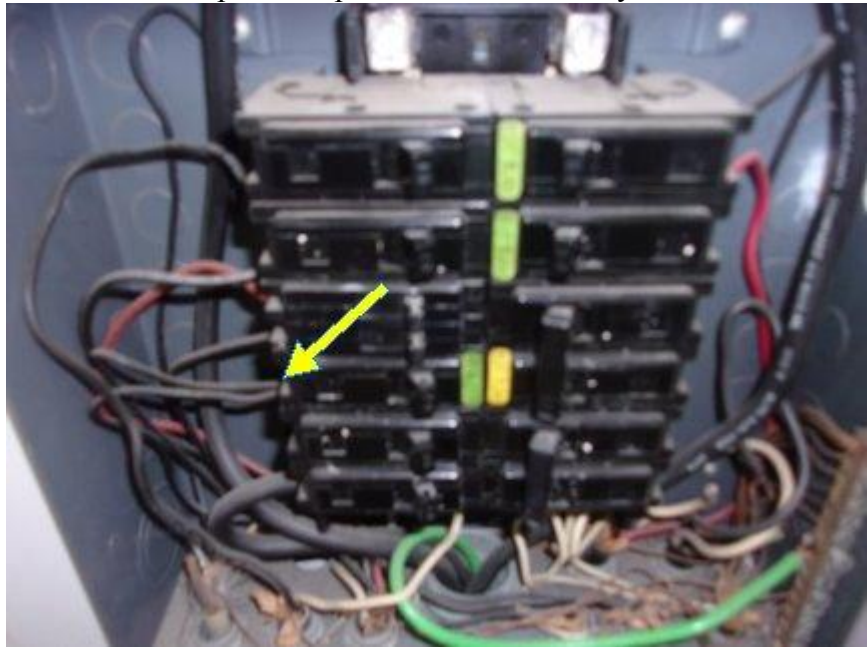
Step #	Component	Comment
1601.	Main Service Drop	Service entrance is underground; Service entrance cables are not visible.
1602.	Main Electrical Panel	The main electrical panel is located in right side. Overload protection provided by breakers. Electrical disconnect is present. System appears to be properly grounded.
1603.	Main Panel Comments	None.
1604.	Wiring Method	Romex. Lighting branch circuit wiring is copper.
1605.	Service Amperage and Voltage	120 & 240 volts. Service panel rating is approximately 100 amps.
1606.	Sub-Panel Comments	<b>Review.</b> The sub-panel(s) is located in master bathroom. Double tapping observed. Double tapping (i.e. 2 wires on a single pole breaker) can add to the load of the affected circuit causing a possible overload and tripping breakers. Recommend review by a qualified professional electrician for repair or replacement as necessary

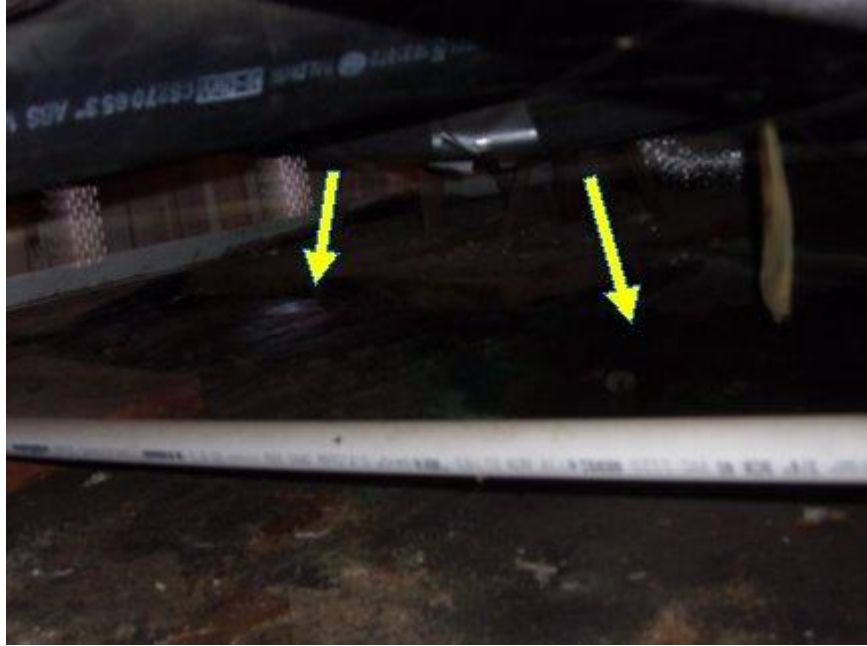
2313. Visible Plumbing **Review.** ABS. Leaking observed at bathroom. Recommend review by a licensed plumber for repair or replacement, as necessary.
