## Duncan Inspection Services

| Inspection #: | 202607-08243 | Inspector: | Duncan Lyons |
| Dwelling Address: | 8200 Jantzen Rd #201<br>Modesto, CA 95357 | Real Estate Company: | Green Valley Homes |

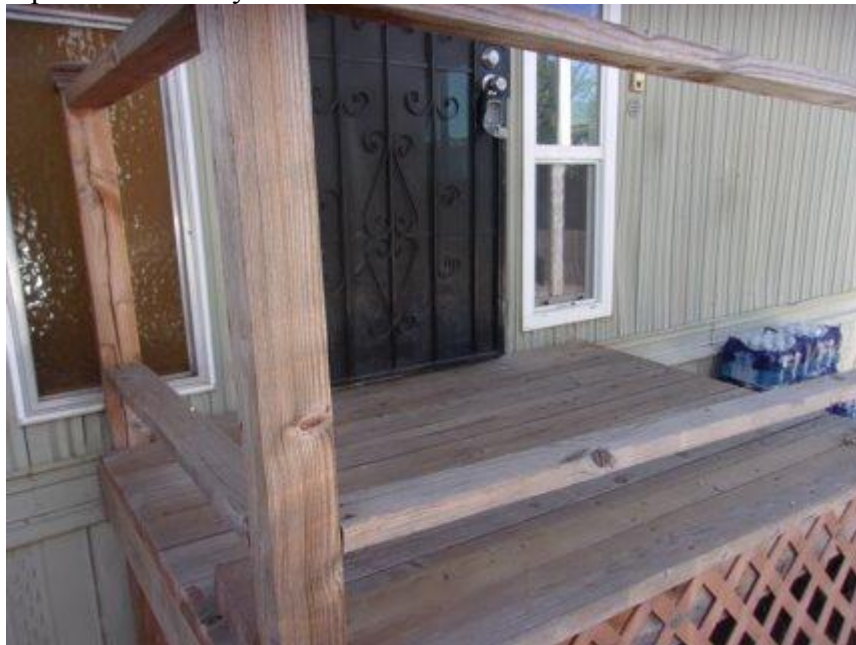
1123. Stairs

**Review.** Wood. Missing balusters and handrail observed. This is a "Safety Concern". Recommend review by a licensed professional for repair as necessary.

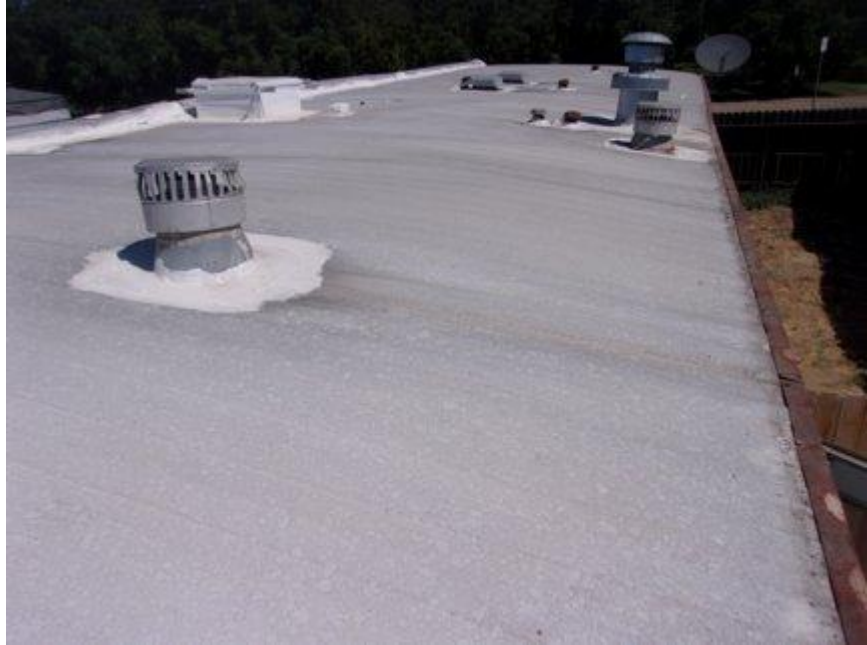
1205.      Conditions      Roof shows normal wear for its age and type. No damaged, deteriorated, or missing roofing materials were observed; it appears to be in serviceable condition.

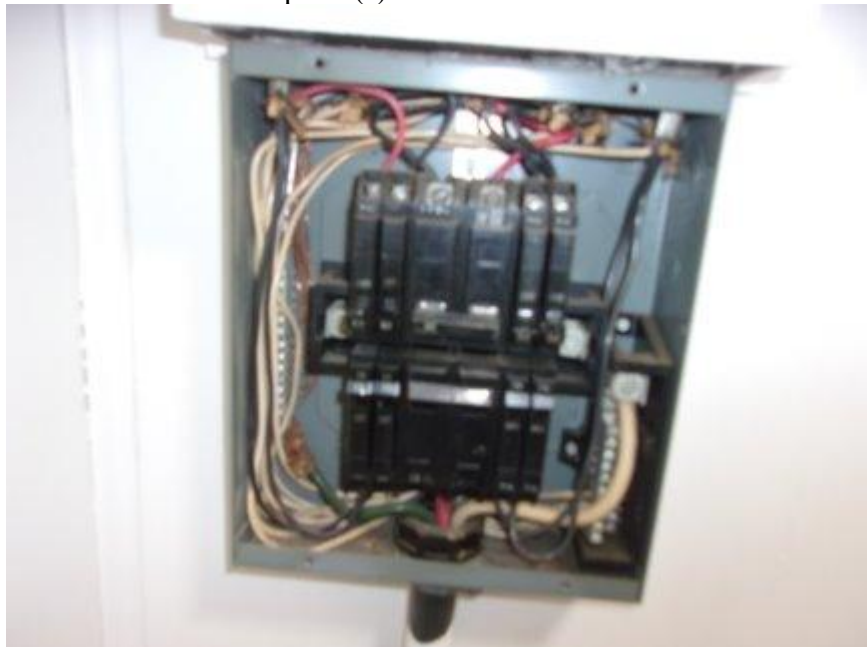
| Step # | Component | Comment |
|---|---|---|
| 1606. | Sub-Panel Comments | Serviceable. The sub-panel(s) is located in master bedroom closet. |

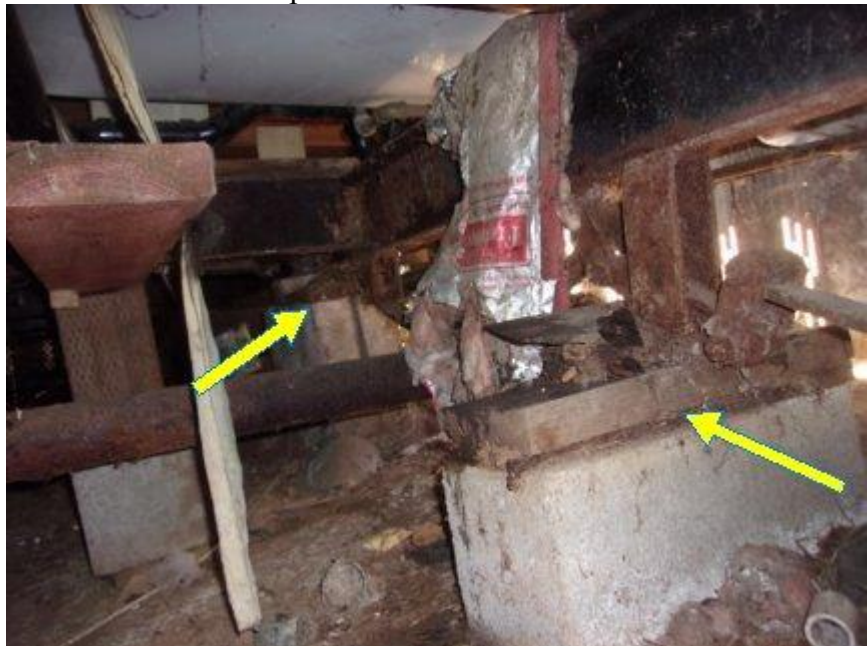
| Step # | Component | Comment |
|---|---|---|
| 2306. | Support Posts / Columns | <b>Review.</b> Concrete blocks; Wood. Wood rot, moisture damage observed under bathroom area, review by a licensed professional is needed for corrections as needed prior to close. |

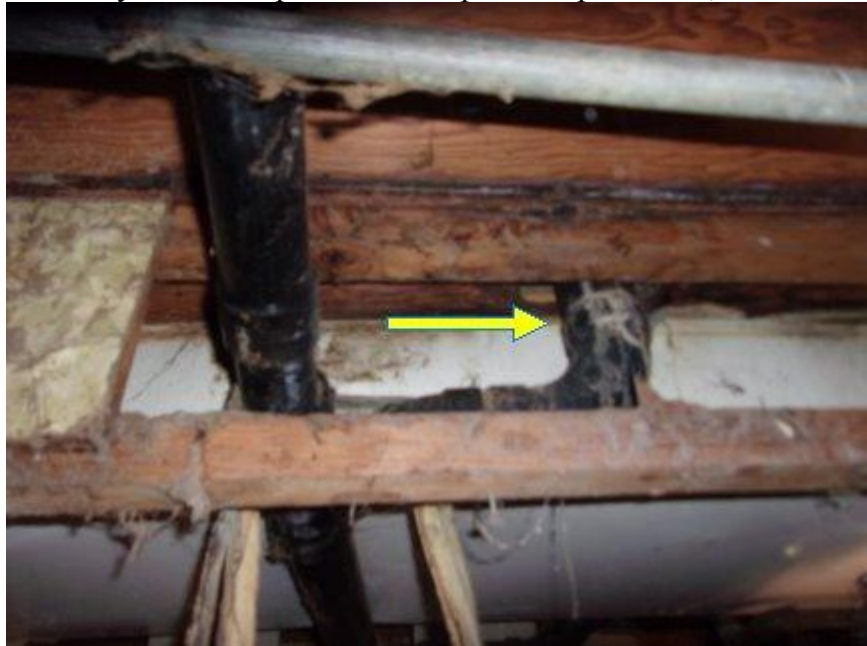
| 2313. | Visible Plumbing | <b>Review.</b> ABS; Galvanized. Leaking observed at bathroom. Recommend review by a licensed plumber for repair or replacement, as necessary. |

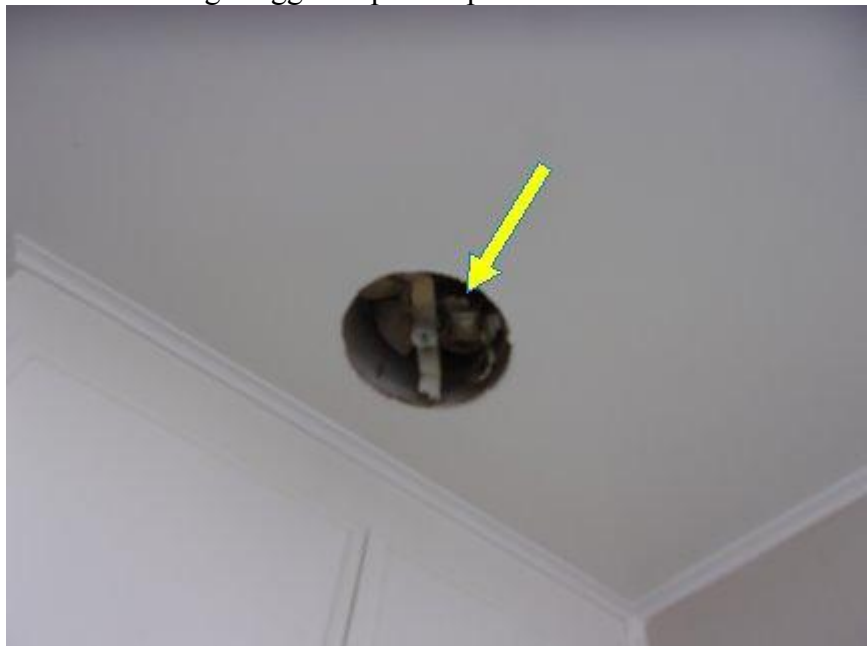
| Step # | Component | Comment |
|---|---|---|
| 3210. | Exhaust Fan | Cover is missing. Suggest repairs/replacements as needed. |

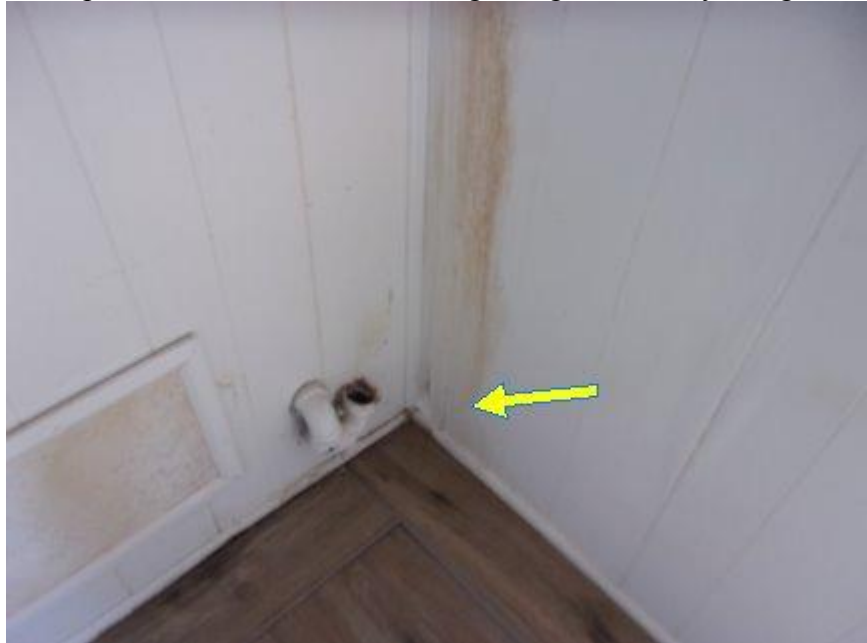
| Step # | Component | Comment |
|---|---|---|
| 3402. | Walls | <b>Review.</b> Paneled. Moisture damaged trim and wall observed. The extent of damage could not be determined without destructive analysis (maintenance and/or repairs should be performed). Suggest reviewing latest pest control report for a more detailed evaluation. See page 4 of full report for further information regarding water entry and growth. |

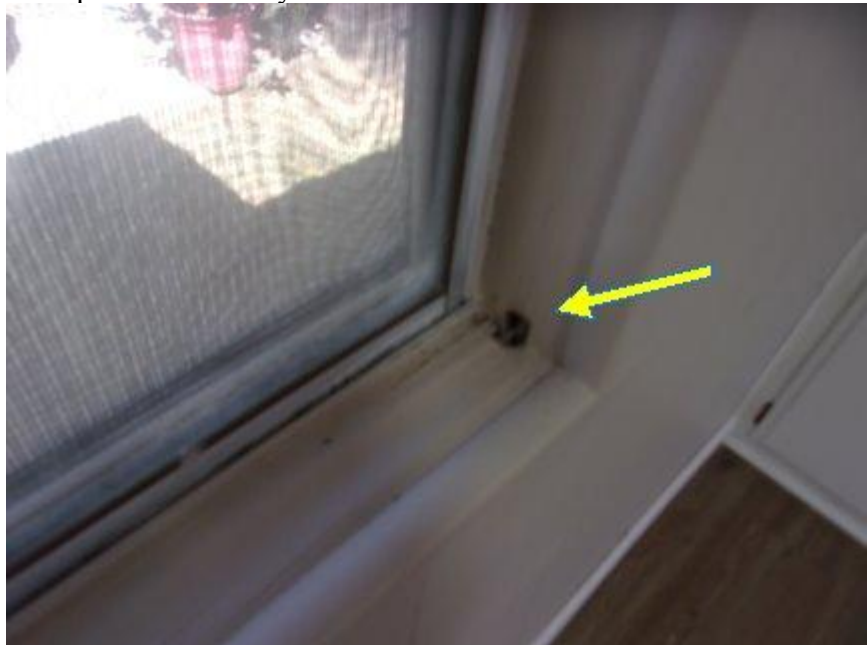
| Step # | Component | Comment |
|---|---|---|
| 3527. | Windows | <b>Review.</b> Dry rot observed at window sill. Recommend further review for repair as necessary. |
