## Duncan Inspection Services

Inspection #:	202604-08210	Inspector:	Duncan Lyons
Date:	4/17/2026	Clients Agent:	Andrew Quintong
Dwelling Address:	8200 Jantzen Rd #127 Manteca, CA 95337	Real Estate Company:	Green Valley Homes
Client Name:	Connie Soriano

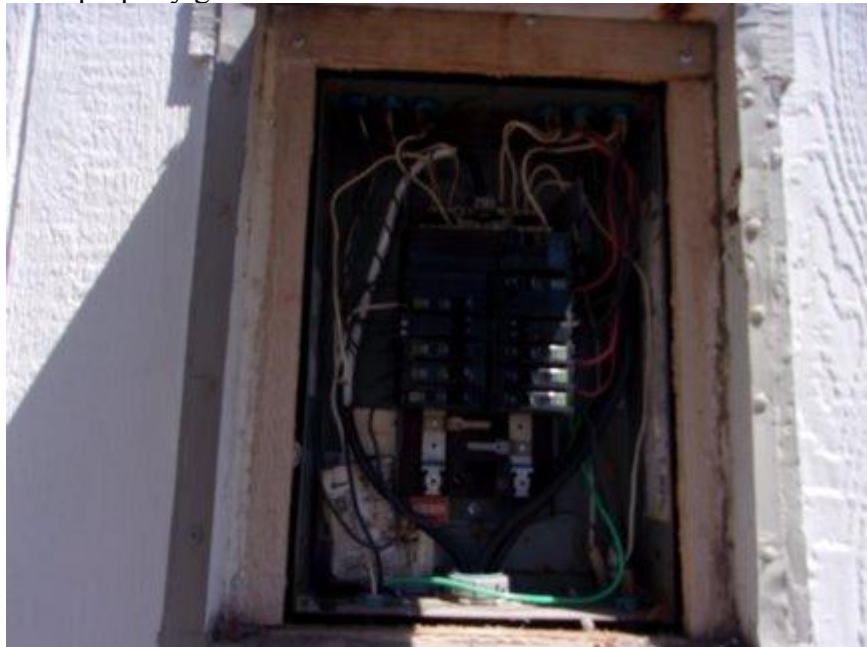
Step #	Component	Comment
1601.	Main Service Drop	Service entrance is underground; Service entrance cables are not visible.
1602.	Main Electrical Panel	The main electrical panel is located in right side. Overload protection provided by breakers. Electrical disconnect is present. System appears to be properly grounded.
