WOOD DESTROYING PESTS AND ORGANISMS INSPECTION REPORT

BUILDING NO. 8200	STREET, CITY, STATE, ZIP Jantzen Rd #156, Modesto CA 95357	Date of Inspection 1/13/2026	No. of Pages 6
-----------------------------	----------------------------------------------------------------------	----------------------------------------	--------------------------

General Description: DOUBLE WIDE MOBILE HOME OCCUPIED	Inspection Tag Posted: SUBSTRUCTURE AREA
	Other Tags Posted: NONE

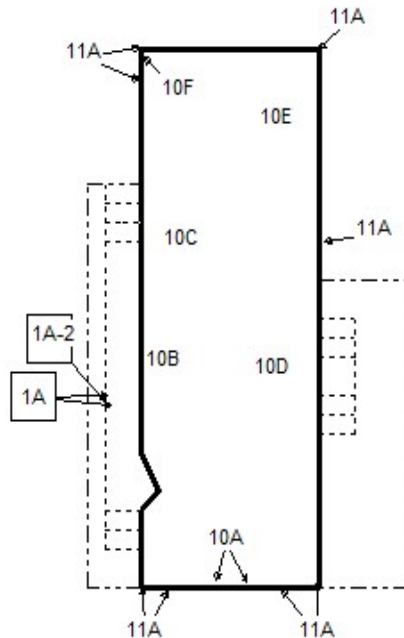
An inspection has been made to the structure(s) shown on the diagram in accordance with the Structural Pest Control Act. Detached porches, detached steps, detached decks and any other structures not on the diagram were not inspected.

RECOMMENDATION Locally treat for the control of Drywood Termites at the areas indicated on diagram. Only the treated areas will be covered under our warranty.
