# WOOD DESTROYING PESTS AND ORGANISMS INSPECTION REPORT

| BUILDING NO.<br><b>8200</b> | STREET, CITY, STATE, ZIP<br><b>Jantzen Rd #201, Modesto CA 95357</b> | Date of Inspection<br><b>7/20/2026</b> | No. of Pages<br><b>6</b> |

| General Description:<br><b>MOBILE HOME</b> | Inspection Tag Posted:<br><b>UNDER KITCHEN SINK</b> |

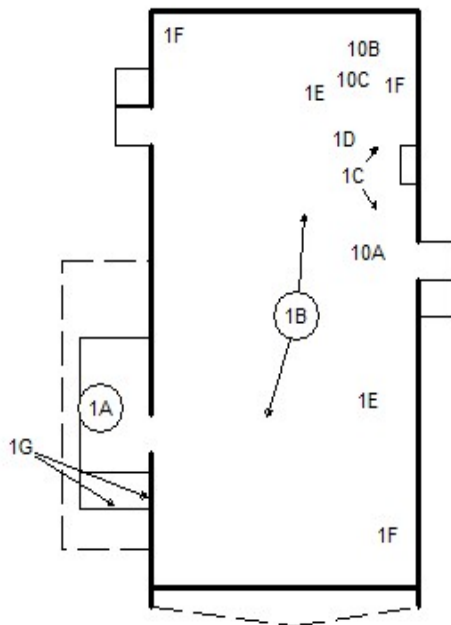
An inspection has been made to the structure(s) shown on the diagram in accordance with the Structural Pest Control Act. Detached porches, detached steps, detached decks and any other structures not on the diagram were not inspected.
